Cover Page

Program ID No. (primary): SWR 80951 Report date: August 2015
TCEQ Region No.: 4 MSD Certificate No.: _____
Additional Program ID Numbers.: SWR/Facility ID No.: _____ PST Facility ID No.: _____
DCRP ID No.: _____ VCP ID No.: _____ LPST ID No.: _____
MSW Tracking No.: _____ HW Permit/CP No.: _____ Enforcement ID No.: _____
Other ID Nos.: EPA CERCLIS TXD980865109

On-Site Property (Facility) Name: Former F.J. Doyle Transformer Salvage/Recycling Facility
Street no. 905 Pre dir: N. Street name: Poplar Street type: St Post dir: _____
City: Leonard County: Fannin County Code _____ Zip 75452
Nearest street intersection and location description: 0.344 acres, SW Corner of N. Poplar St and E. Cottonwood St

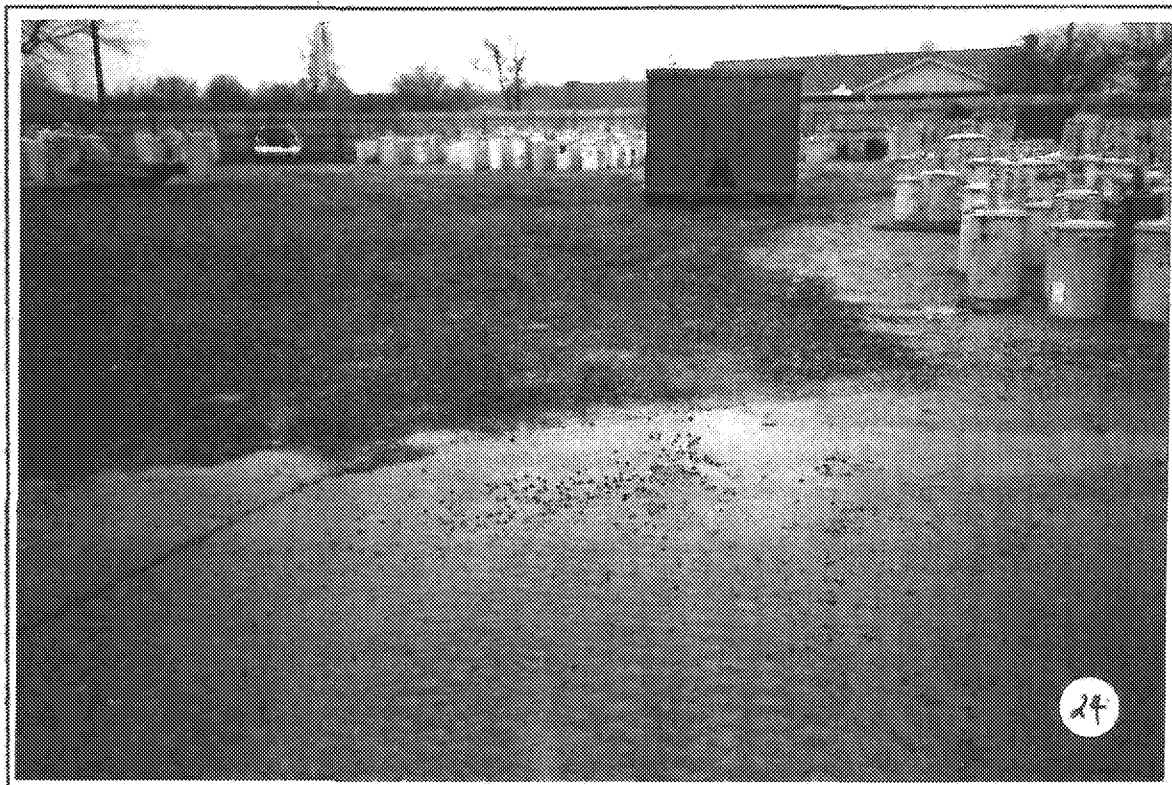
Photo #24 - Overview photo of the transformer off-load area located in the north central portion of the site. Note the 1.5 to 3.0 KVA transformers stored along the fenceline waiting for processing.

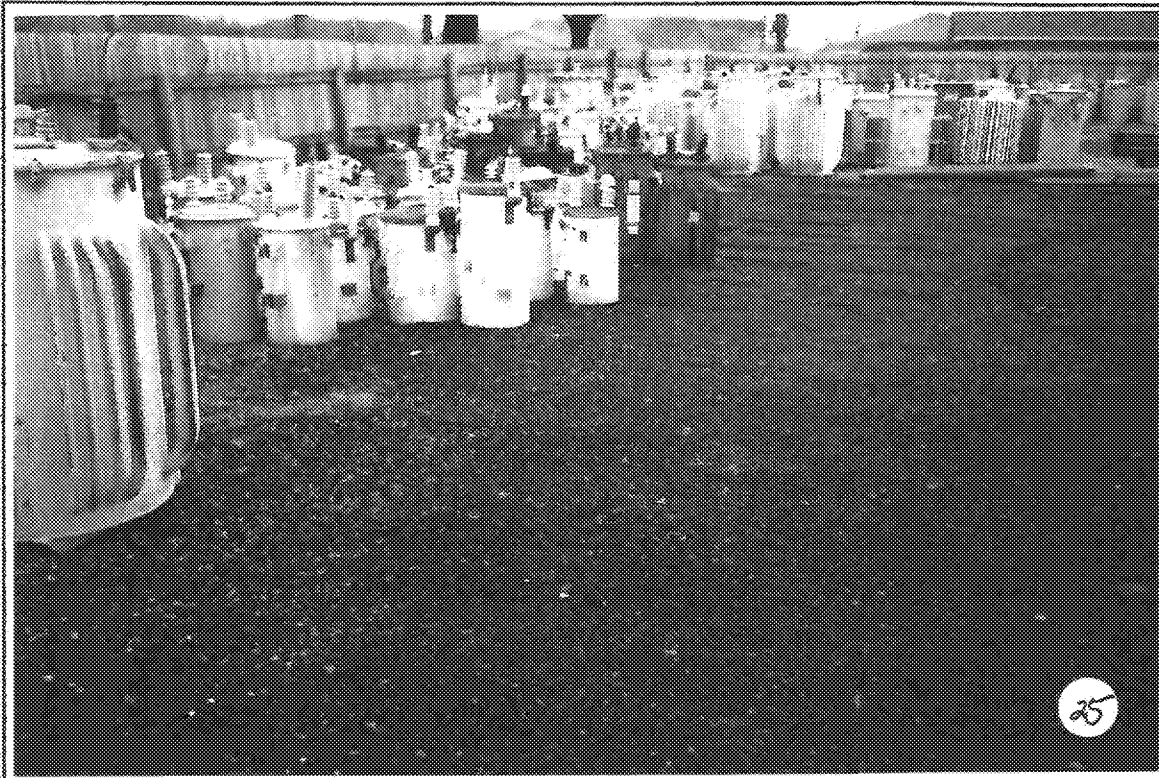
Photo #25 - According to the facility manager, transformers ranged from 1.5 to 500 KVA and were tested and drained before received from the supplier. A typical delivery consisted of 30-50 transformers as shown above.

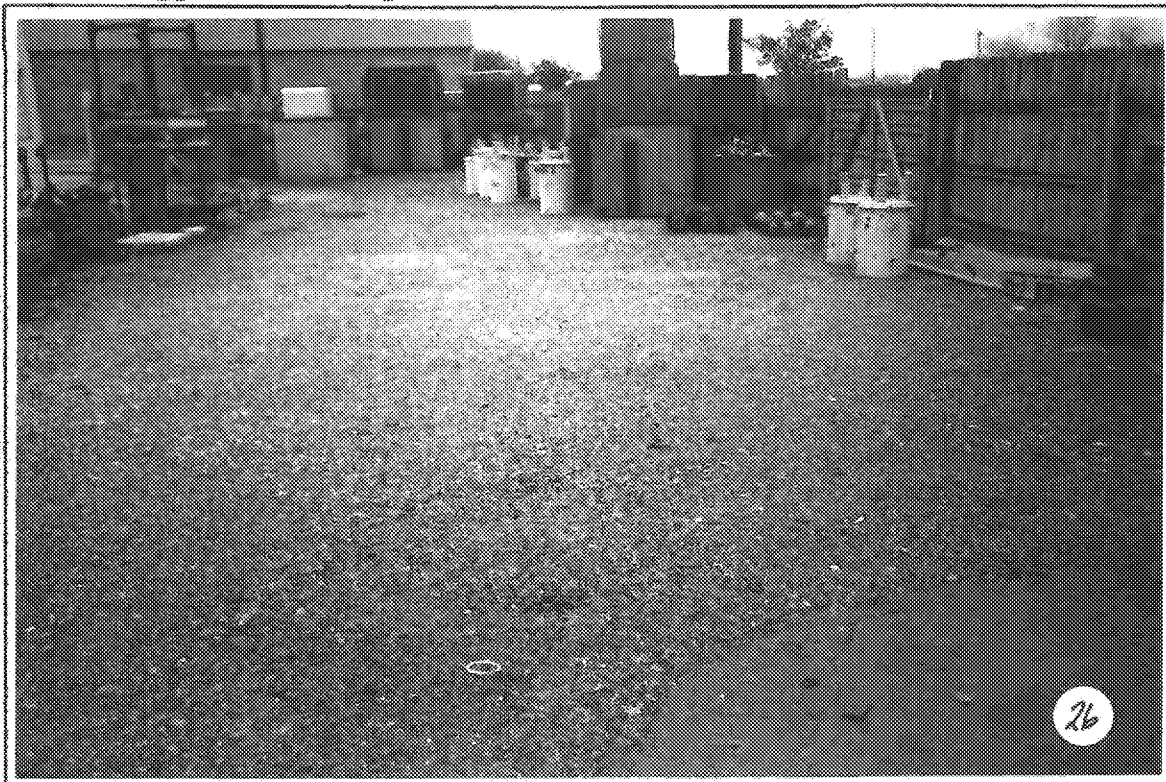
Photo #26 - Larger transformers were placed by forklift and stored in the southeast corner of the site east of the south gate as shown above. Photo taken facing east.

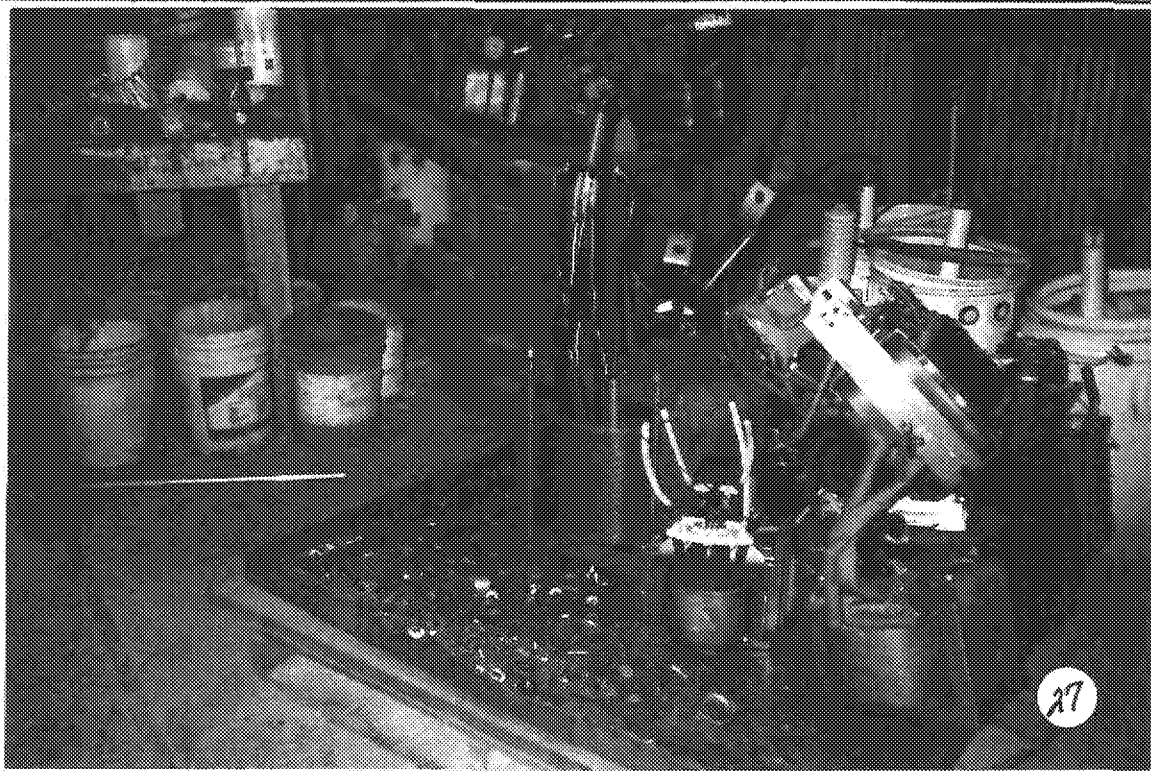
Photo #27 - Residual transformer oil is pumped from the transformer casing to 55 gallon drums and the copper/aluminum cores removed to drip drain as shown above.

The facility receives used power transformers shipped from various companies located in Texas, Oklahoma, Louisiana and Arkansas that are off-loaded and stored on site. Residual oil is pumped from the transformer casings and placed in storage tanks located in the bermed concrete storage area. The transformer cores are then removed and placed on a draining table to allow any remaining oil to displace, which is placed in 55-gallon storage drums. The drained cores are then placed in an oven to bake off remaining oil, paper and varnish. The baked cores are removed, cooled and stripped for recoverable metals. Accumulated transformer oil is transferred from the storage tanks to trucks and shipped off-site to an authorized disposal/recycling facility by an authorized waste oil transporter (see site photographs #23 thru #31, Appendix A). According to the facility owner, Mr. Frank J. Doyle, the facility only accepted non-PCB filled transformers beginning in the late 1970's; however, prior to then transformer oil was not tested and some of the drained oil had been distributed to various individuals throughout Leonard for use as weed control (ref 5, page 2).

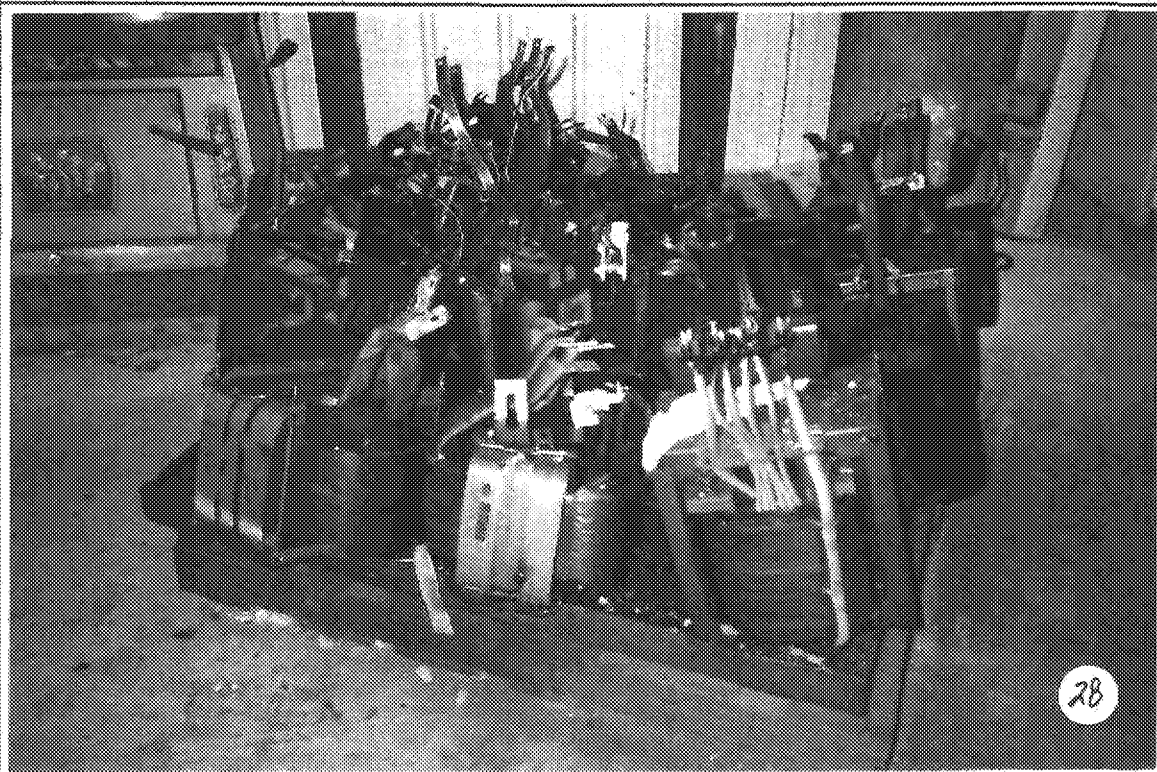
Photo #28 - The accumulated transformer oil is pumped from the drip pan to 55 gallon drums and the copper/aluminum cores removed from their casings.

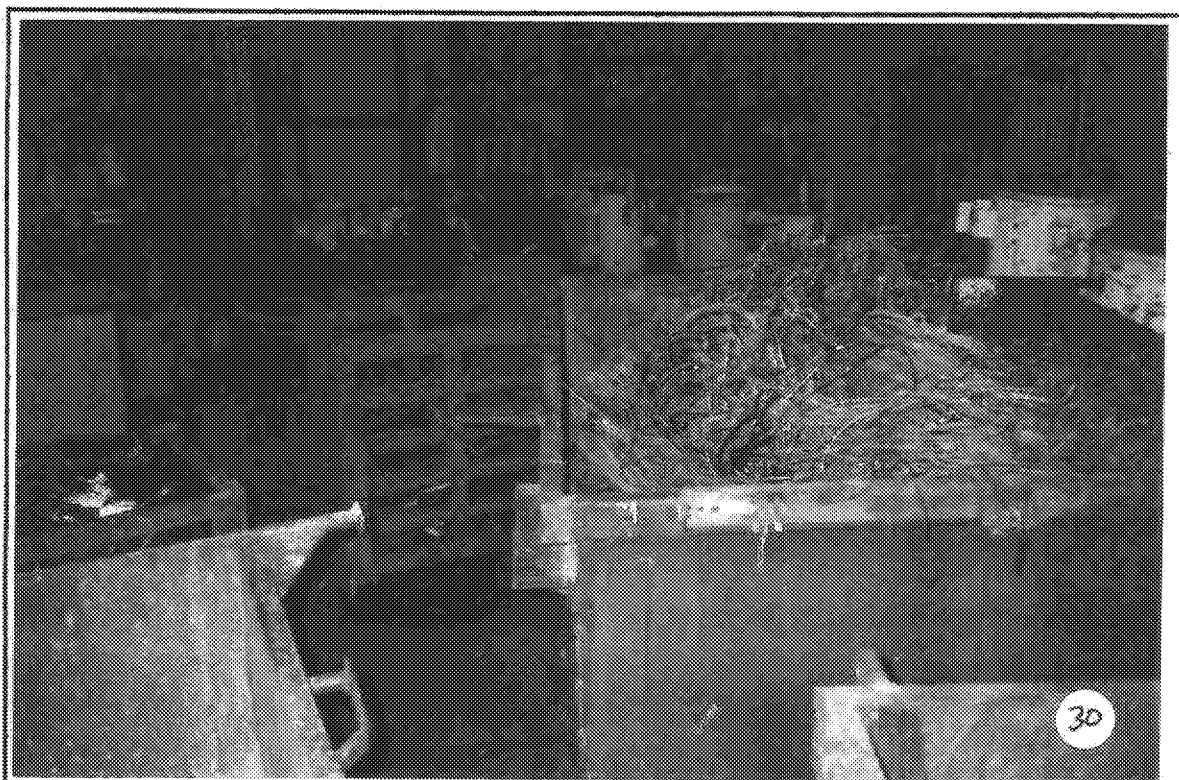
Photo #30 - The baked cores are stripped of copper/aluminum and placed in bins for recycling as shown below.

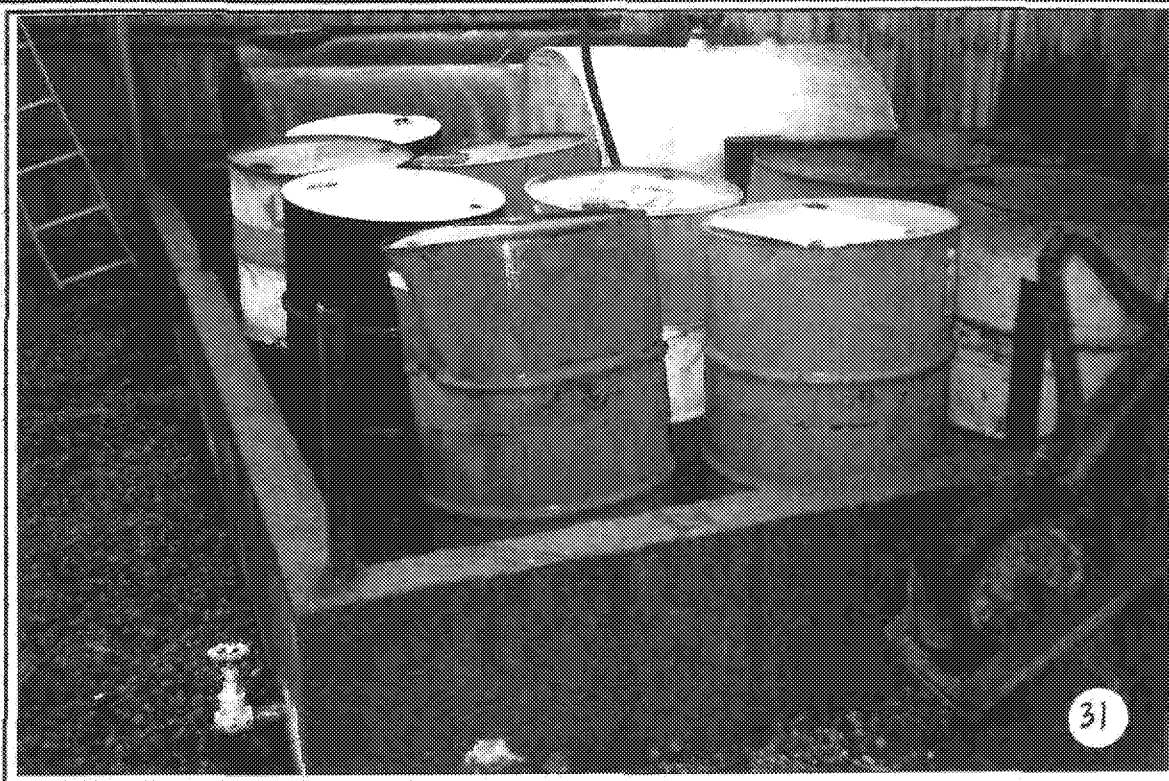
Photo #31 - Used transformer oil is stored in a concrete bermed container storage area in three tanks and 55-gallon drums as shown above. The oil is picked up by an oil recycling service periodically. Photo taken facing south.
